DEEP-OCEAN BIODETERIORATION
OF MATERIALS — PART III. THREE
YEARS AT 5,300 FEET

U. S. NAVAL CIVIL ENGINEERING LABORATORY
PORT HUENEME, CALIFORNIA

Technical Report R-428

James S. Muraoka

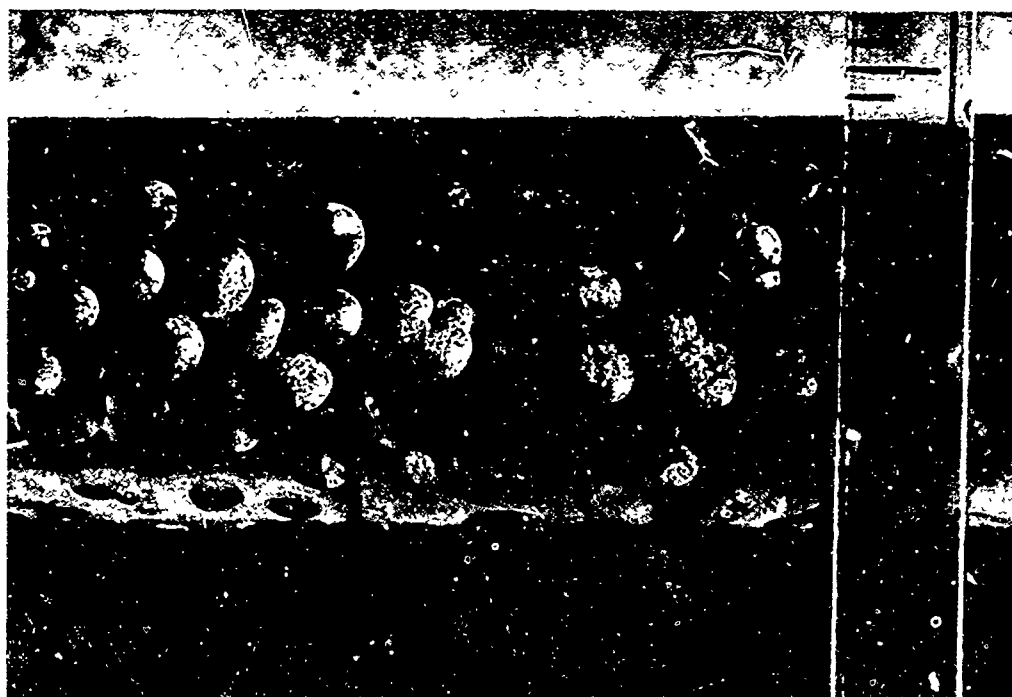
Figure 27. Over 100 holes made by borers on the surface of a cellulose acetate plastic rod around an area under the wooden bait piece. The wood was destroyed by the borers.

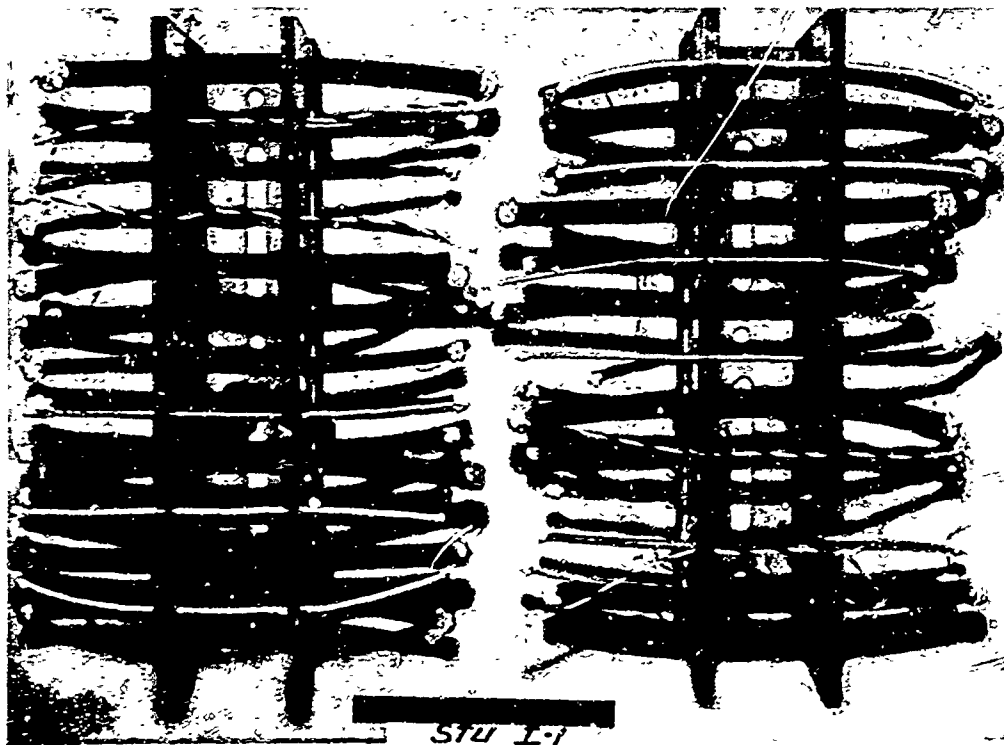
Figure 31. Single and multiconductor electrical cables after 35 months near the sea floor. Hydroid growth can be seen attached to the insulation.
